DELAYED OR HARSH REVERSE ENGAGEMENTS - 5R55S TRANSMISSION - VEHICLES BUILT PRIOR TO 09/23/2004

TECHNICAL SERVICE BULLETIN

Reference Number(s): 05-21-8, Date of Issue: October 31, 2005

FORD: 2004-2005 Thunderbird, Explorer

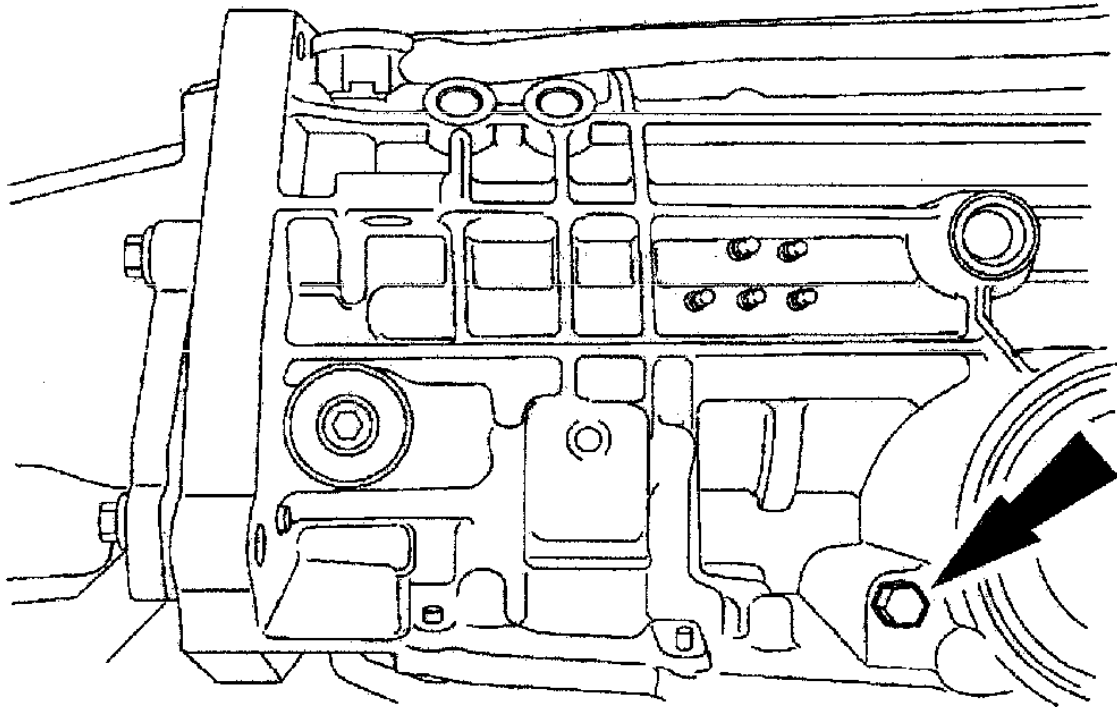
G00401083

1. Remove pressure tap plug at PCC port ([Fig. 1](#)).

Fig. 1: Pressure Tap Plug At PCC Port

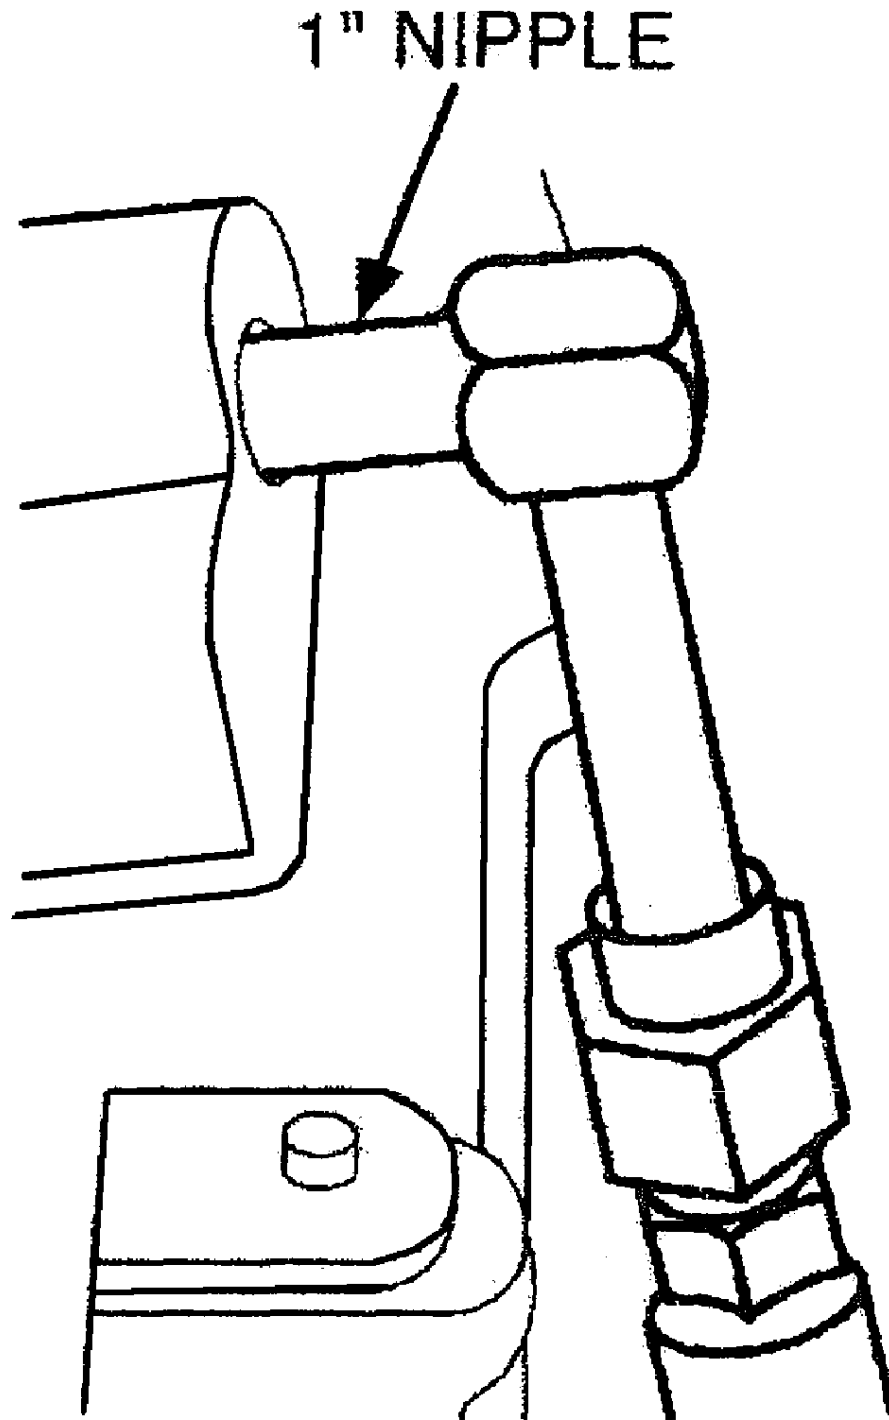
G00401082

2. Install a pressure gauge into the PCC port, using a 1" long nipple and a 90 degree fitting ([Fig. 2](#)).

Fig. 2: Nipple And 90 Degree Fitting In (EPC) Port
