TECHNICAL SERVICE BULLETIN

SYNC Screen Concerns, Wi-Fi Connection Message, Rear View Camera Operation, CarPlay And/Or Voice Prompt Concerns

20-236319 October
2020

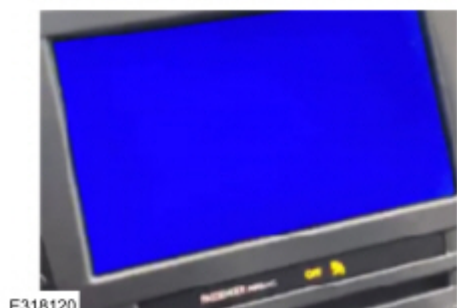
Figure 1

- Solid blue screen when moving forward at speeds above 16 km/h (10 mph) (Figure 1)
 - The rear parking aid camera remains on the screen at speeds below 16 km/h (10 mph) (Figure 2)

This may be due to the SYNC Software. To correct the condition, follow the Service Procedure to update the accessory protocol interface module (APIM) software.

1. Disconnect all customer connected USB items from all media hub locations.
2. Start the vehicle.
3. Insert the SYNC 3 universal thumb drive into the USB port on the media hub.
4. The module automatically updates with no user input required.
 - (1). Modules already at the latest software level will indicate this after approximately 30 seconds.
 - (2). Module programming for a non-updated module does not need to be monitored and can take approximately 20-30 minutes.
 - (3). Once the reprogramming has completed, the screen will display a message indicating the module is up to date.
5. Remove the SYNC 3 universal thumb drive when complete. The screen returns to the SYNC 3 home screen. Reconnect any of the customer USB items. No vehicle or system restarts are required.
