## Exterior Lighting Condensation Warranty Coverage Job Aid

### Examples of Normal Exterior Lighting Condensation NOT Covered by Warranty

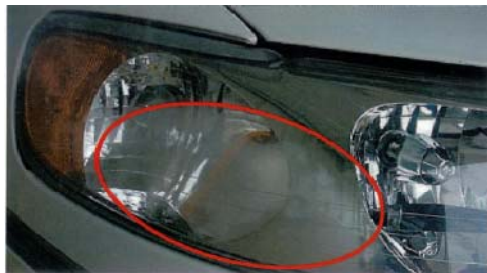
**Figure 7)** No drip marks/ streaks in the finely condensed film on the interior side of the clear plastic lens.

Figure 7: No streaks/ drips marks in the condensation

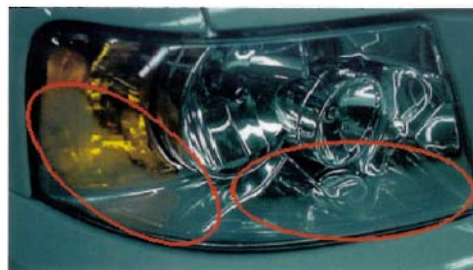
**Figure 8)** There are no visible water droplets in the thin mist

Figure 8: No visible water droplets in the thin mist.

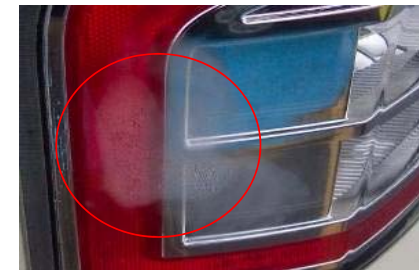
**Figure 11)** No water droplets in the mist of rearlamps

Figure 11: No water droplets in the mist of rearlamps

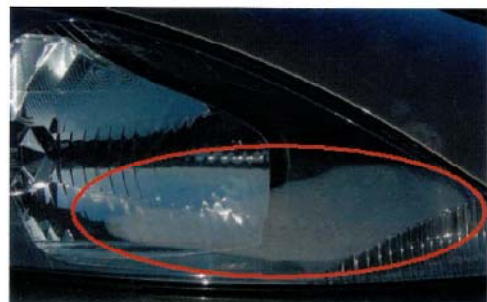
**Figure 9)** The fine mist does not obstruct the view of the interior of the lamp.

Figure 9: Mist does not obstruct the view of the lamp's interior.

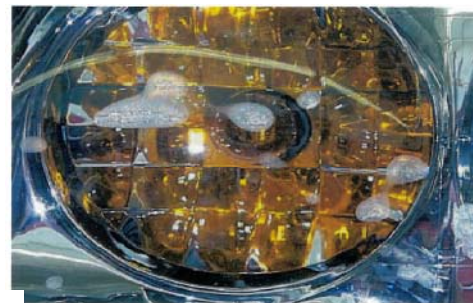
**Figure 10)** Condensation covers less than 50% of the interior side of the lens.

Figure 10: Fine Mist covers less than 50% of the lens

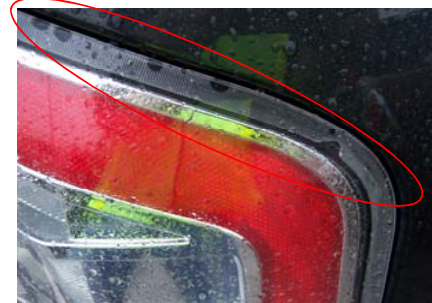
**Figure 12)** Water droplets outside lens perimeter.

Figure 12: Water droplets outside of lens perimeter.

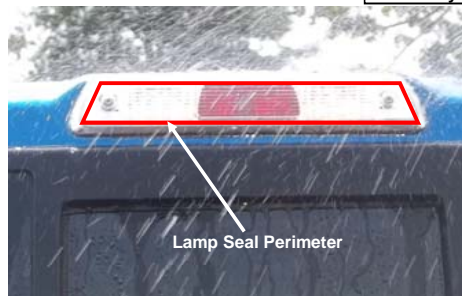
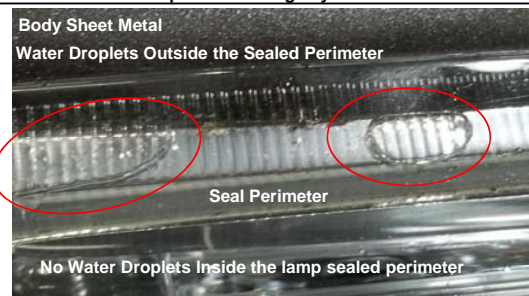
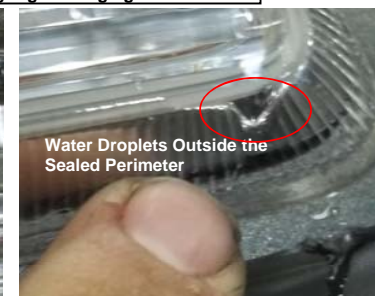
Figure 13) Water droplets outside lens perimeter.

Figure 13: Water droplets outside of lens sealed perimeter.

**F150 CENTER HIGH MOUNT STOP LAMP (CHMSL). WATER DROPLETS OUTSIDE THE LENS-TO-HOUSING SEAL PERIMETER. DROPLETS WILL EVENTUALLY BLOW OUT, OR EVAPORATE.**

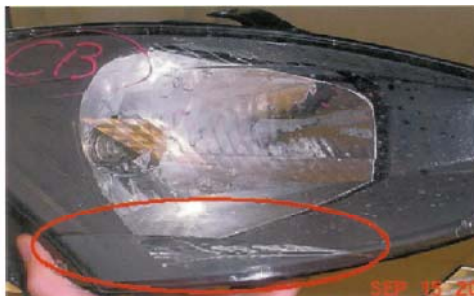
Figure 1: Puddle of water

If a headlamp/rearlamp is diagnosed with having non-normal condensation (a leak), first check TSBs for lamp repair procedure before replacing the lamp. If there is a TSB then follow the repair procedure. If there is no TSB for a repair procedure, then proceed with replacing the lamp.

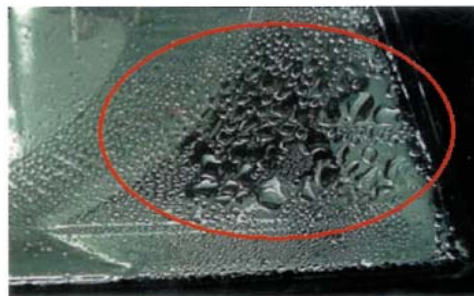
Figure 2: Large water droplets

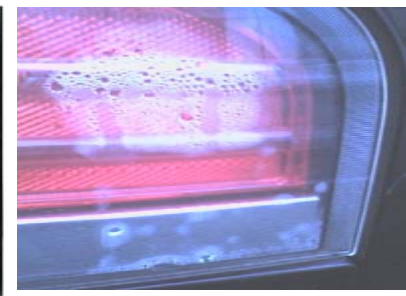
Figure 5: Drips forming in the film condensation

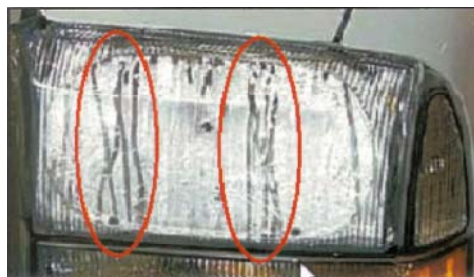
Figure 3: Drip marks/streaks in condensation

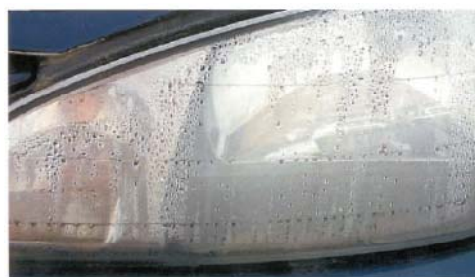
Figure 4: Thick mist covering the lens with water droplets.

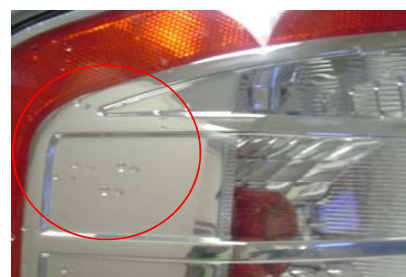
Figure 6: Drip marks/droplets in the interior of lamp
