5R55S/5R55N/5R55W TRANSMISSIONS - SHIFT CONCERNS, LOSS OF 2ND, 3RD AND 5TH GEAR, INCORRECT RATIO DTC'S - PROCEDURE TO INSPECT AND REPAIR SERVO PIN BORE WEAR

TECHNICAL SERVICE BULLETIN

Reference Number(s): 09-12-12, Date of Issue: June 29, 2009

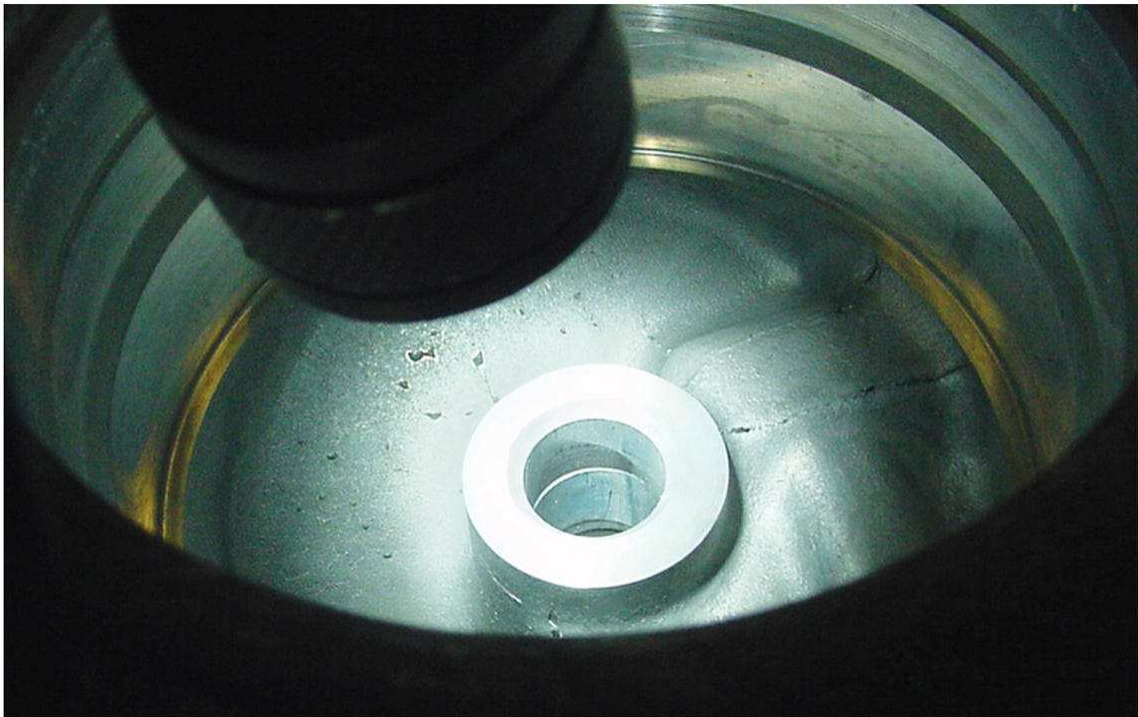
Fig. 1: Servo Pin Case Bore

For transmissions that have been determined to require an overhaul or rebuild and the overdrive band or intermediate band have excessive wear or burned/damaged band friction material, the cause maybe excessive servo pin case bore wear generally found on higher mileage vehicles, usually accompanied with incorrect ratio diagnostic trouble codes (DTCs), condition becomes worse when hot. ([Fig. 1](#))

In our instructions, when we refer to the overdrive bore, we are talking about the smaller bore located closest to the bell housing. When we refer to the intermediate bore, we are talking about the larger bore located next to the line pressure tap.

Inspect and repair the worn-damaged transmission case servo pin bore utilizing the Rotunda Tool 5RW Master Kit part number NRL5RW servo pin bore repair system (1-800-768-8632 ☎ option 6).

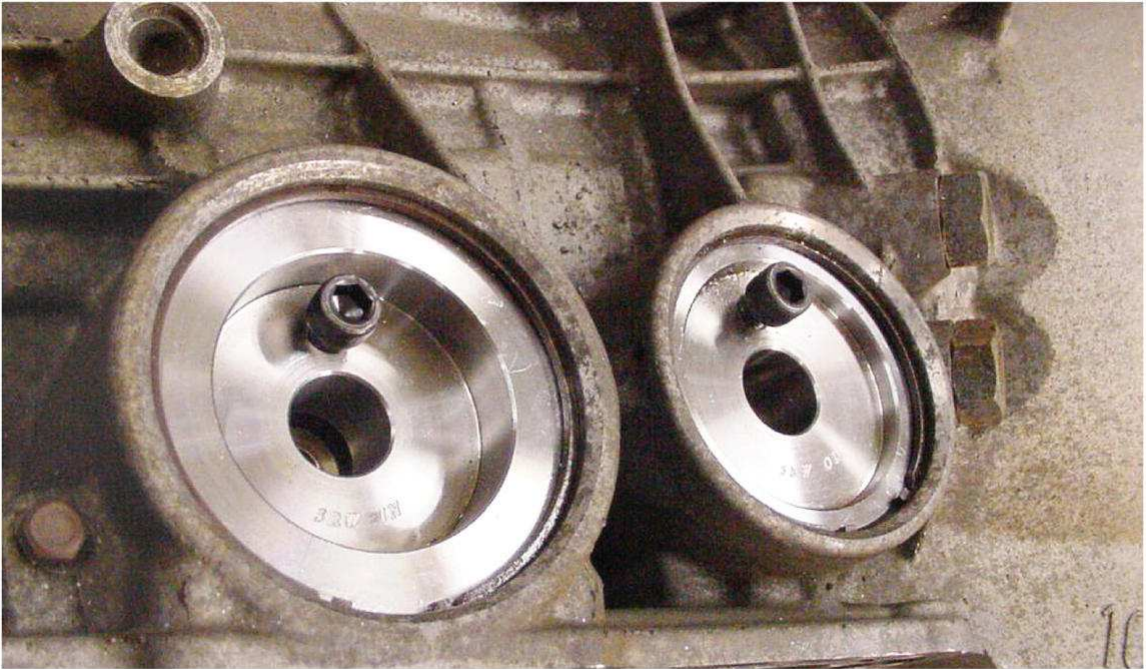
Fig. 2: Drill Jig Installation

1. Install the drill jig into the case by setting the jig into the case servo bore. Retain the jig in the case with the servo's snap-ring. ([Fig. 2](#))

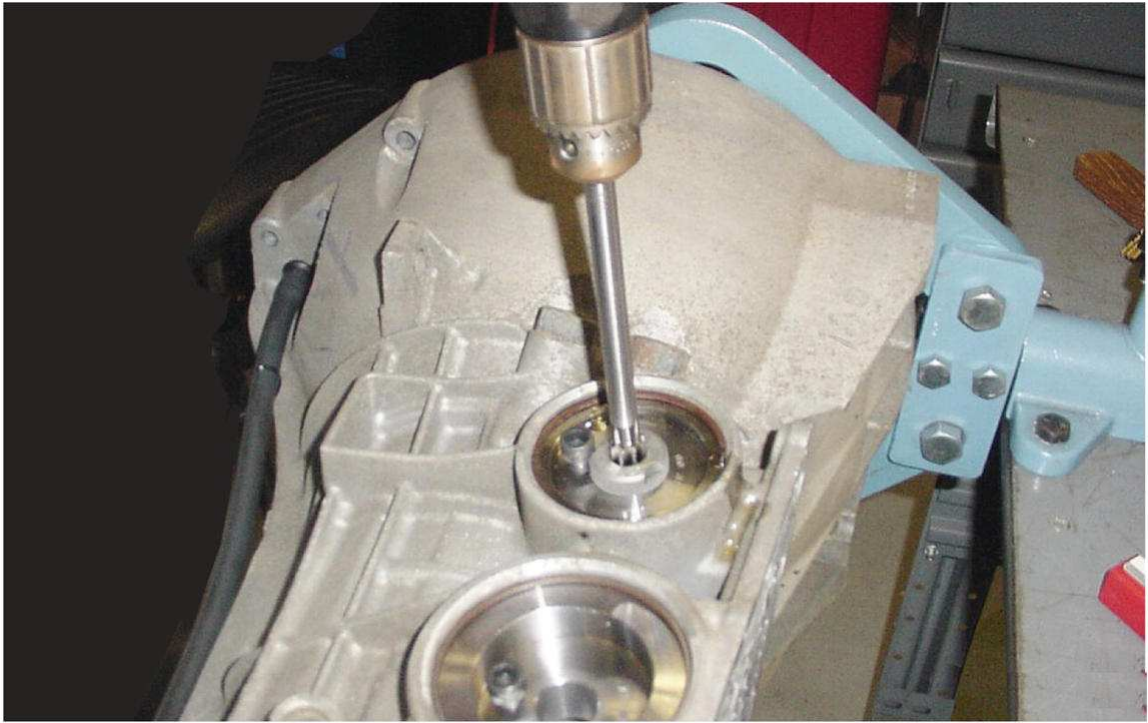
Fig. 3: Reaming Servo Pin Case Bore

3. Ream out the bore using the 9/16" reamer, applying ample lubrication.

NOTE: DO NOT REAM ABOVE 500 RPM. ([Fig. 3](#))

NOTE: CUTTING OIL MUST BE USED FOR LUBRICATION. THE USE OF SUBSTITUTES, PARTICULARLY ATF, MAY RESULT IN AN OVER-SIZED BORE.

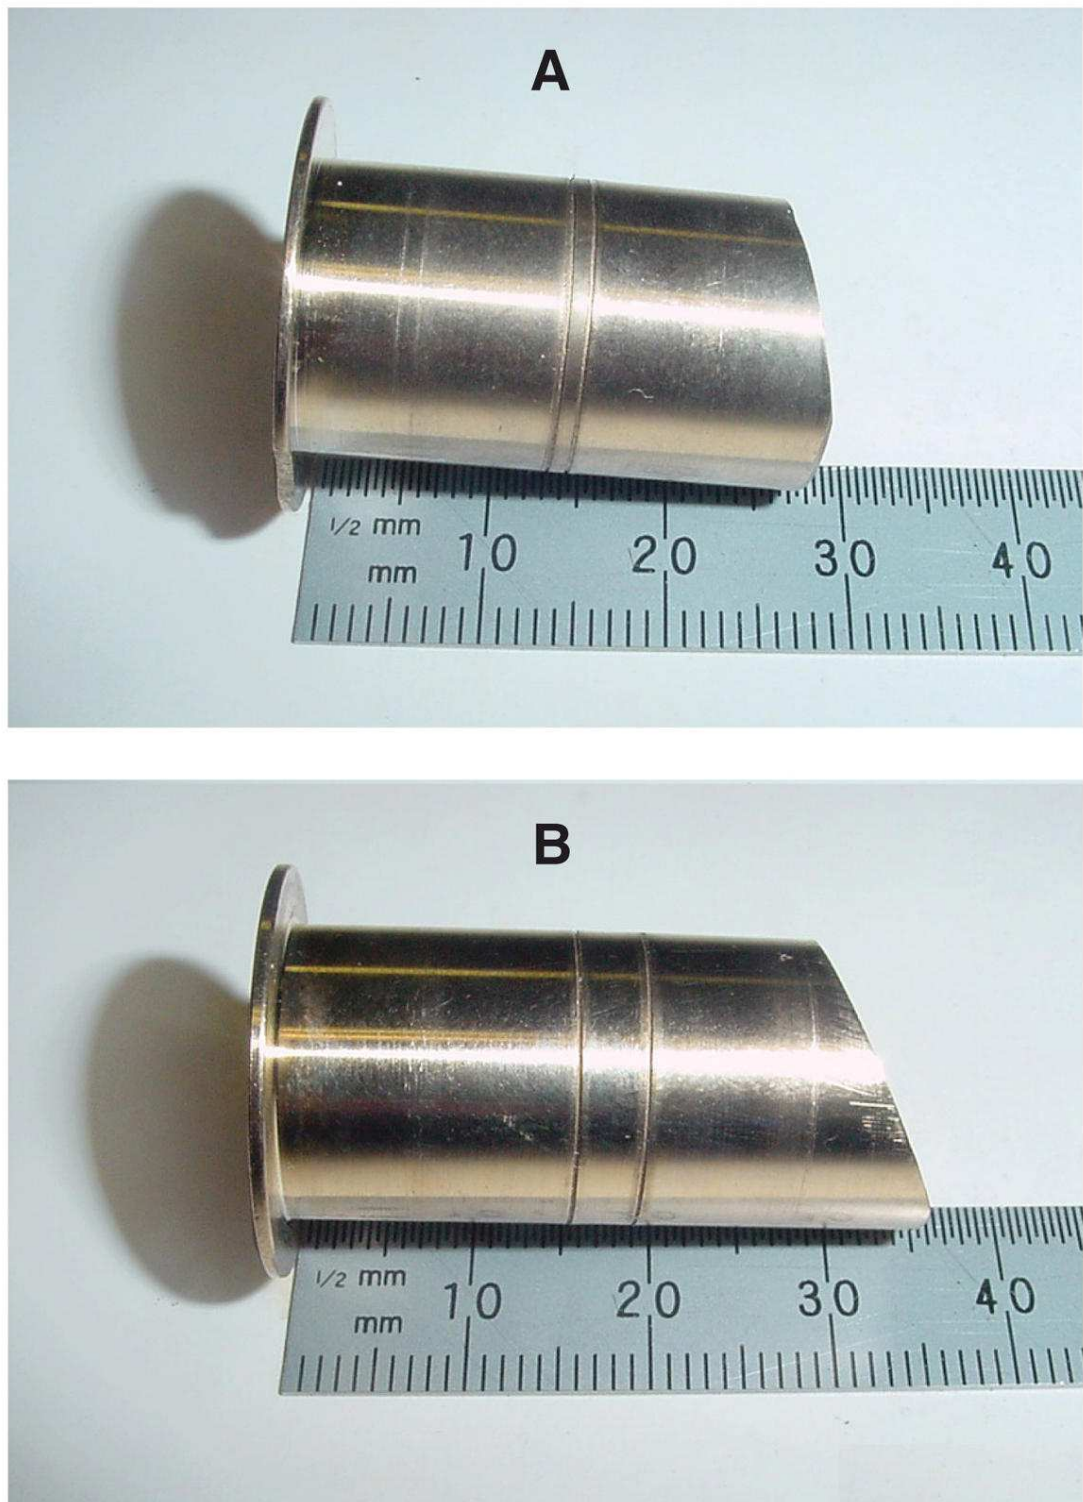
Fig. 4: Intermediate Servo And Overdrive Servo Bushings

4. Replace the 9/16" reamer guide with the 5/8" guide, and the 9/16" reamer with the 5/8" reamer.
5. Ream the bore out using the 5/8" reamer with ample lubrication. Take care not to either push too hard on the reamer or turn the reamer faster than 500 RPM when reaming. Either one can overly enlarge the bore, causing a loose bushing.
6. Clean the case before proceeding to Step 7. This kit utilizes two different bushings.
 - a. The shorter bushing is for the intermediate servo and is identified by a flat ground in the bushing's hat. ([Fig. 4A](#))
 - b. Overdrive servo bushing. ([Fig. 4B](#))

- c. Both bushings are chamfered and need to be installed with the recessed edge up (away from the valve body).
7. Apply Loctite® 680 Retaining Compound or equivalent to the outside of the bushing and drive the bushing in by hitting the driver until the bushing bottoms. ([Fig. 5](#)) The 5RW kit uses a smaller diameter installation tool identified by a groove cut in the handle.

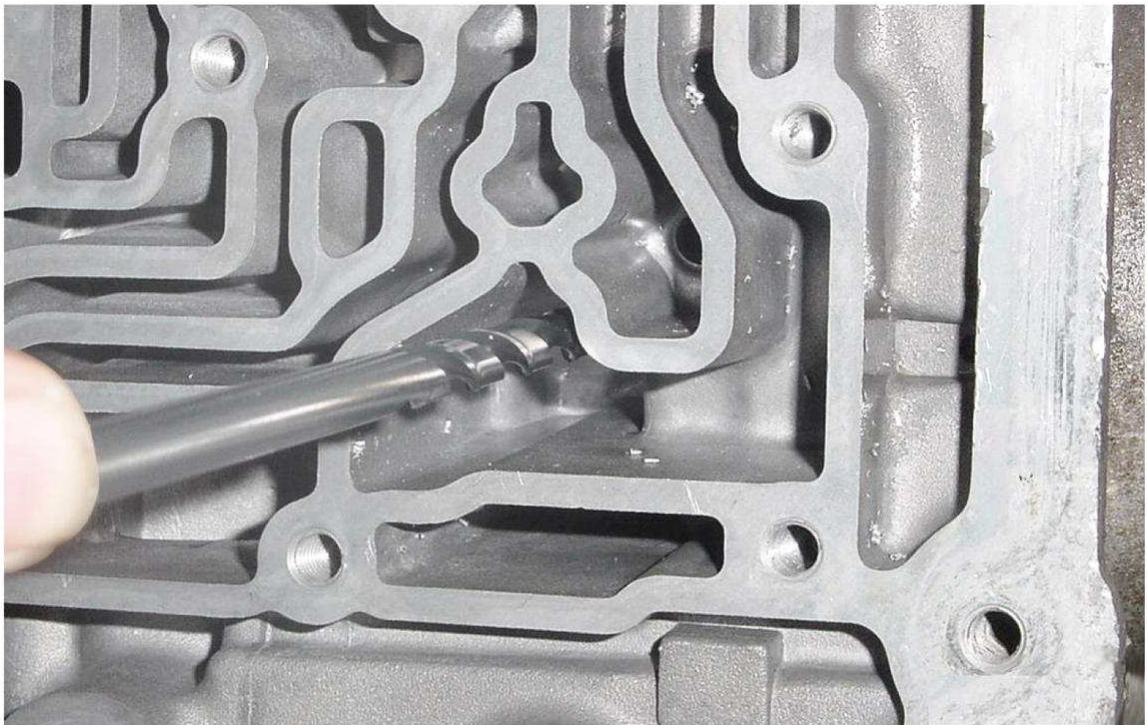
Fig. 6: Overdrive Servo Apply Hole

8. After installing the bushing, using a 15/64" bit, drill a hole in the side of the bushing by following the servo apply holes in the case 5R55S case shown.
 - a. Overdrive servo. (**Fig. 6**)

NOTE: **FAILURE TO PERFORM CROSS DRILL STEP IN THE NEW BUSHING WILL RESULT IN A NO SHIFT CONDITION.**

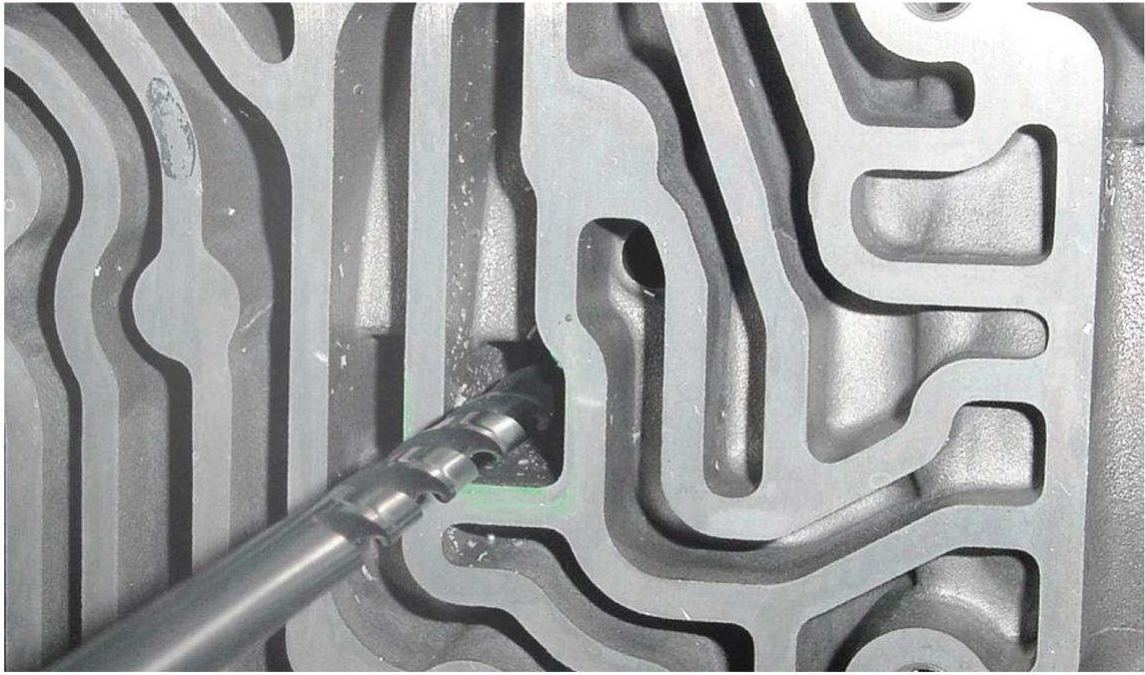
Fig. 7: Intermediate Servo Apply Hole

b. Intermediate servo. ([Fig. 7](#))

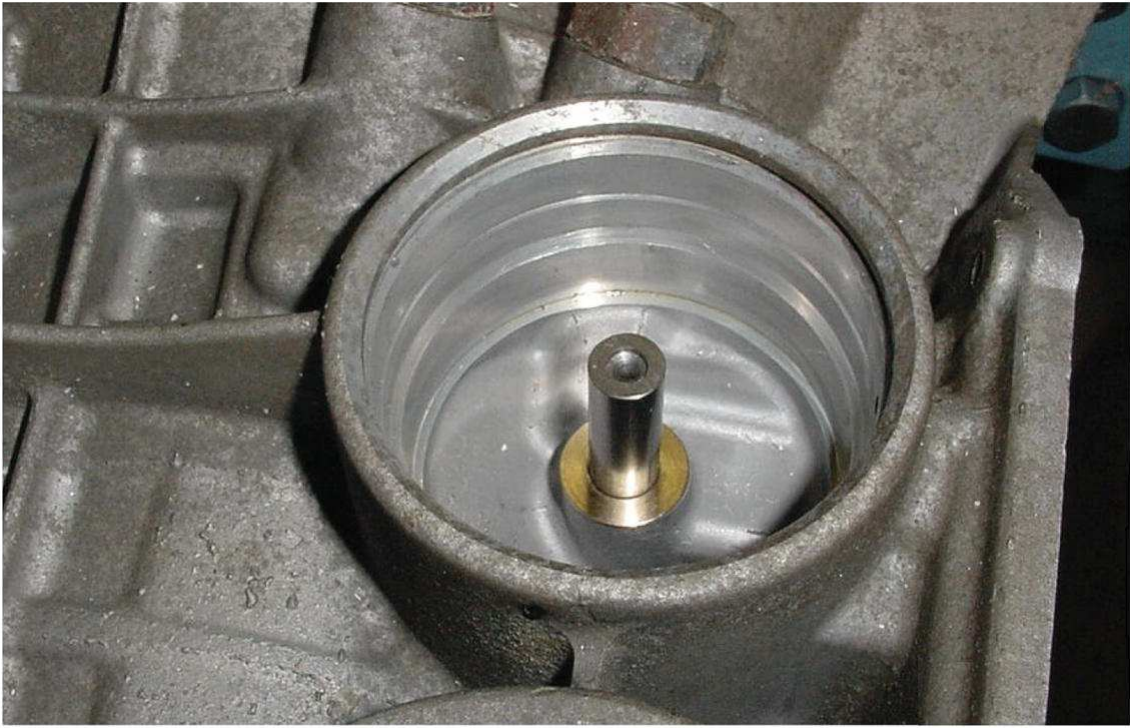
Fig. 8: Sizing Pin Inserted Into Bore

9. Insert the provided sizing pin into the bore. It maybe necessary to start the pin in the bushing with a rubber mallet. Once the pin is inside the bushing, use a punch to drive the pin all the way through the bushing. Repeat as necessary. ([Fig. 8](#))

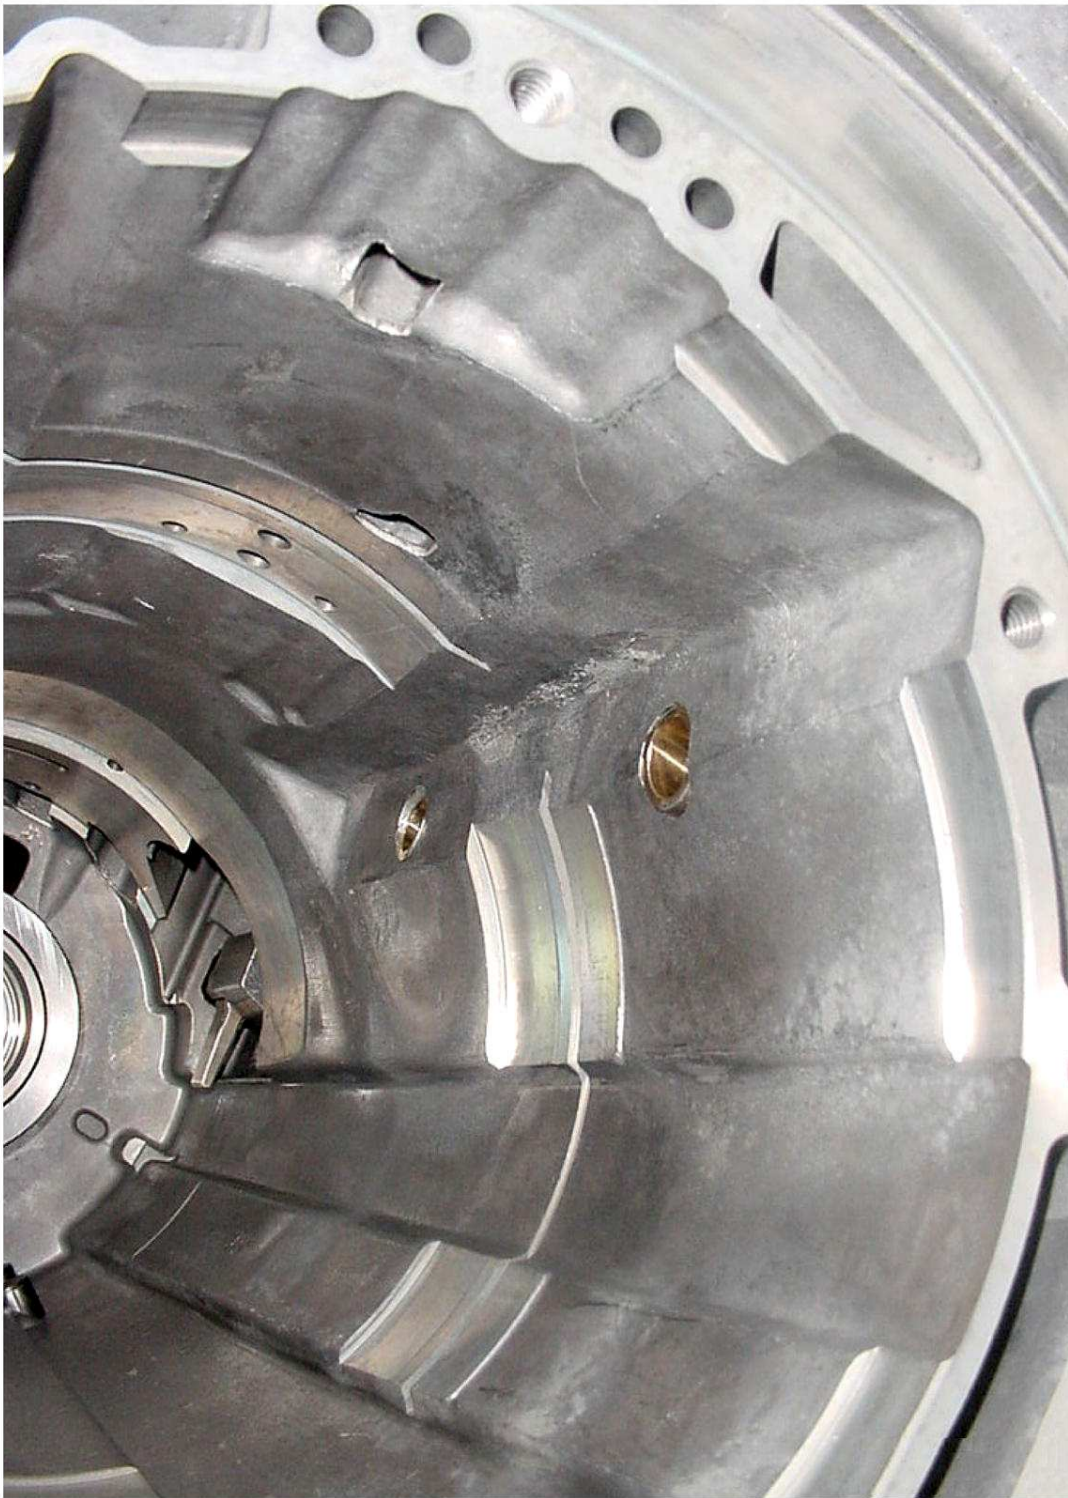
Fig. 9: Bushings Flush Inside Of Case

Correctly installed bushings will be flush inside of case. (**Fig. 9**)
